Richmond Refinery LPS Bulletin – Reliability

Hydrogen leak on F-355 East Outlet Header

Location:
Richmond Refinery

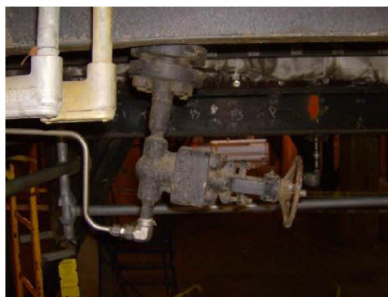
Bent piping to instrumentation root valve on the outlet header

- 1) The crack in the piping connection to PI-3577 was due to the stress from the connection being bent.
- 2) The Investigation Team could not determine the cause of the bend or when the piping was bent.
- 3) The bend most likely occurred from a collision with a piece of equipment.

- 1) When performing work in operating units, regardless if you are an employee or contractor, it is vital to notify the Head Operator or Shift Team Leader, if you happen to collide with piping or equipment. Even if no apparent damage has occurred, the proper personnel should be notified so any potential unseen damage can be investigated and any necessary corrective actions can be implemented to prevent a potential incident from occurring.

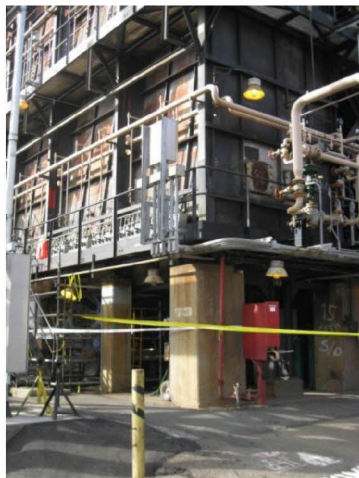
Repair work being completed on outlet header.
